Subject:
Letter Report
Removal of Underground Diesel Piping System at GE San Germán Facility
Case 16-196

This letter report summarizes the activities conducted by Arcadis from January 31, 2017 through April 12, 2017 related to the removal of the 375 lineal feet

underground diesel piping system as authorized by PRIDCO in their Work Plan Approval Letter dated January 4, 2017.

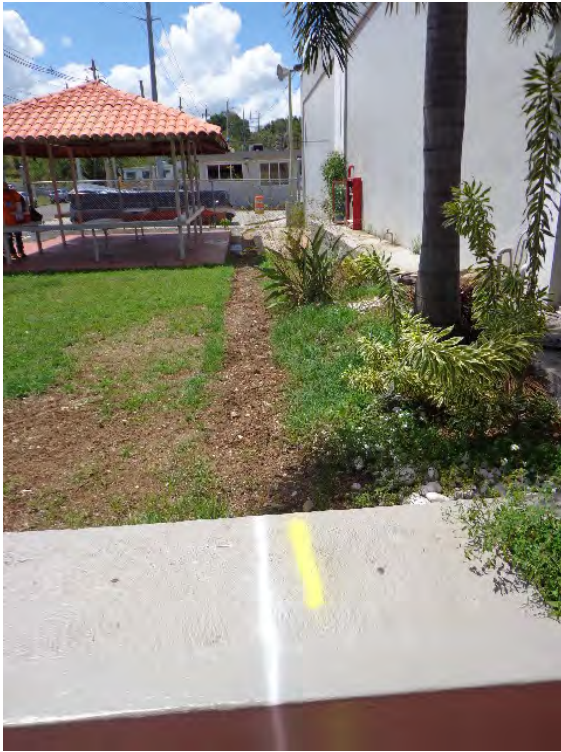
Photograph: 29

Description: Backfilled trench/excavation after soil sample result showed TPH-DRO concentration <100 mg/kg.

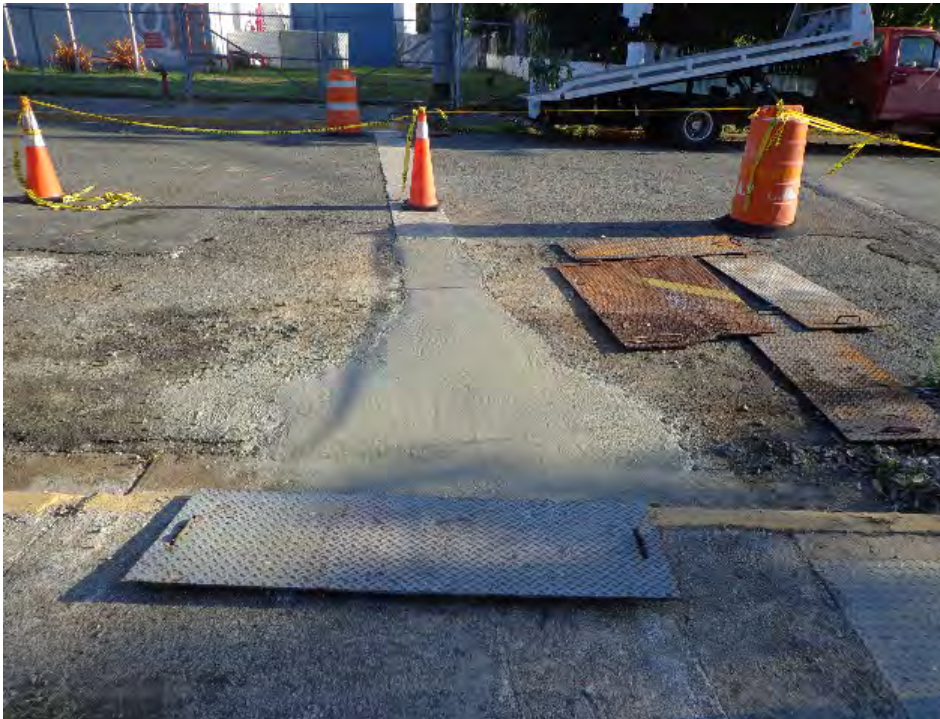
Photograph: 30

Description: New concrete slab after trench/excavation soil sample result showed TPH-DRO concentration <100 mg/kg.

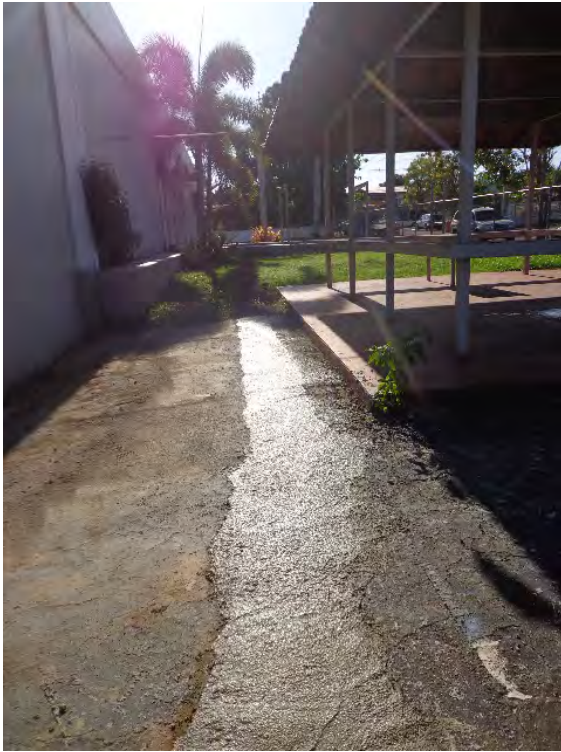
Photograph: 31

Description: New concrete slab after trench/excavation soil sample result showed TPH-DRO concentration <100 mg/kg.

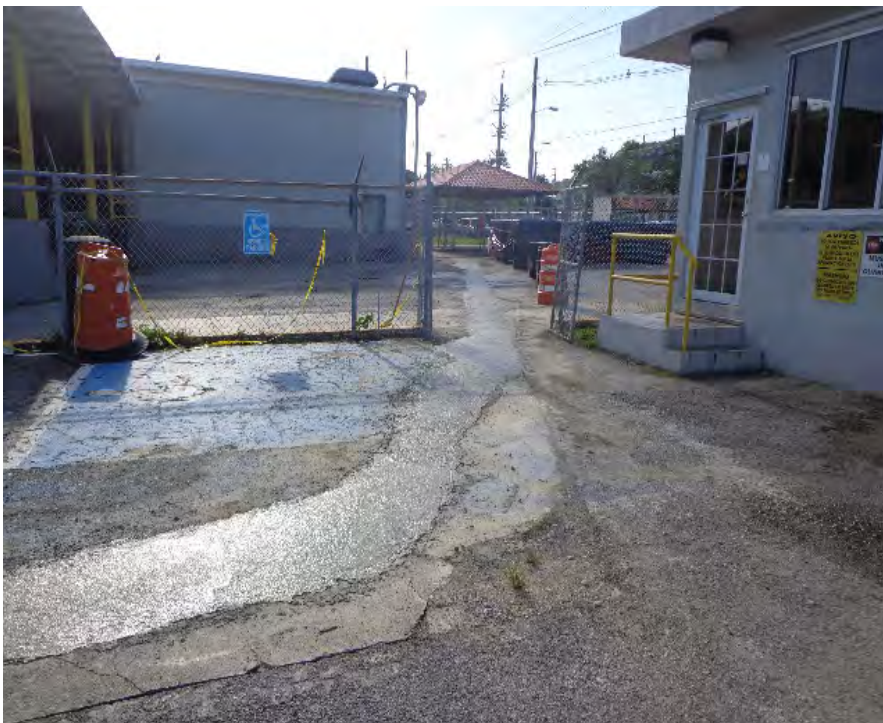
Photograph: 32

Description: New concrete slab after trench/excavation soil sample result showed TPH-DRO concentration <100 mg/kg.

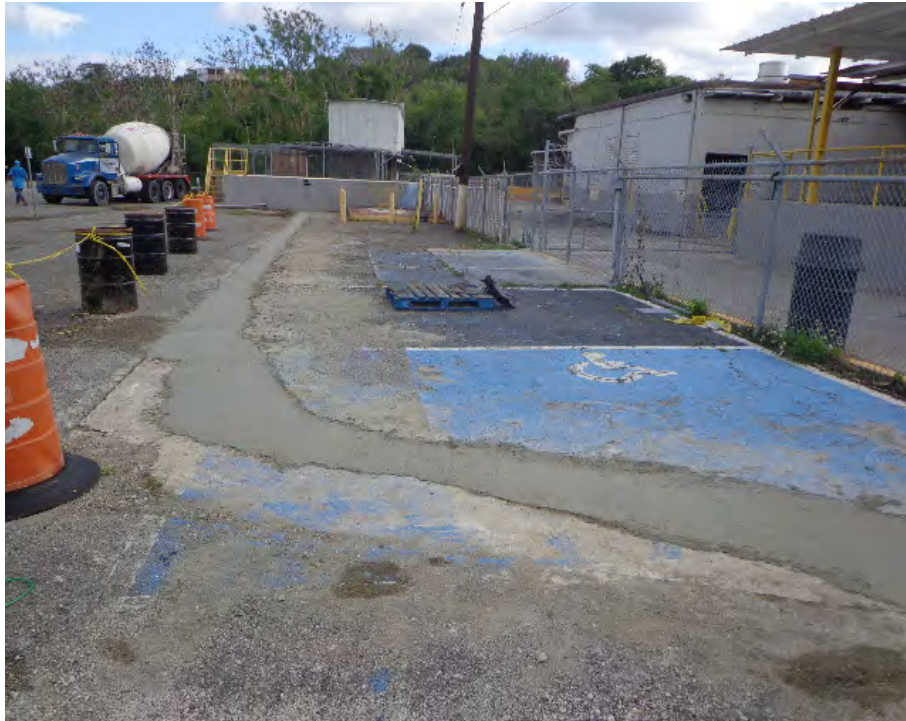
Photograph: 33

Description: New concrete slab after trench/excavation soil sample result showed TPH-DRO concentration <100 mg/kg.

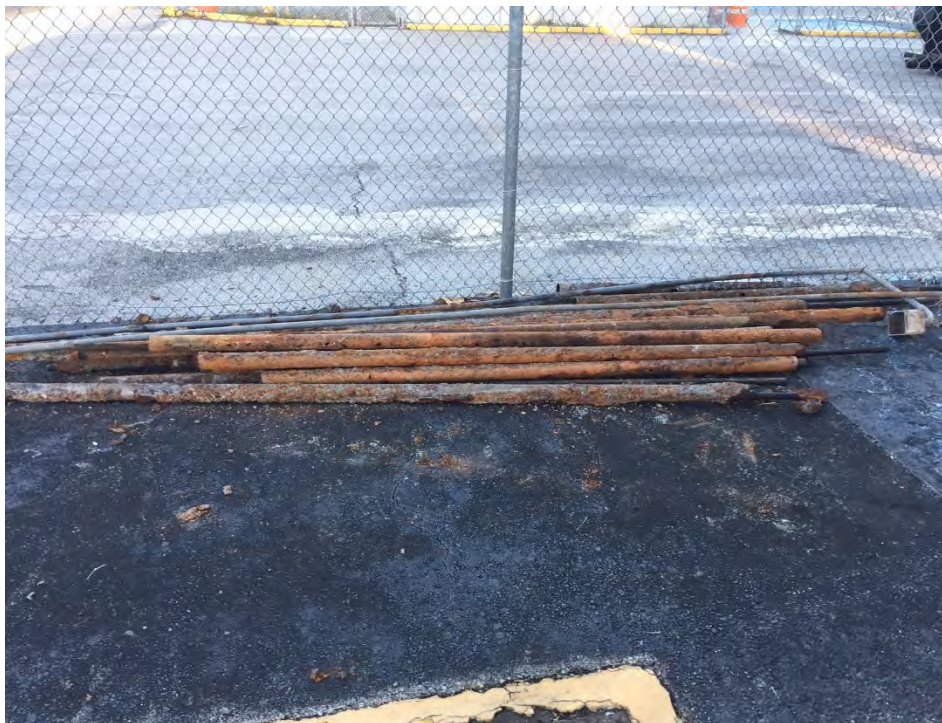
Photograph: 34

Description: View of pieces of pipelines after removal

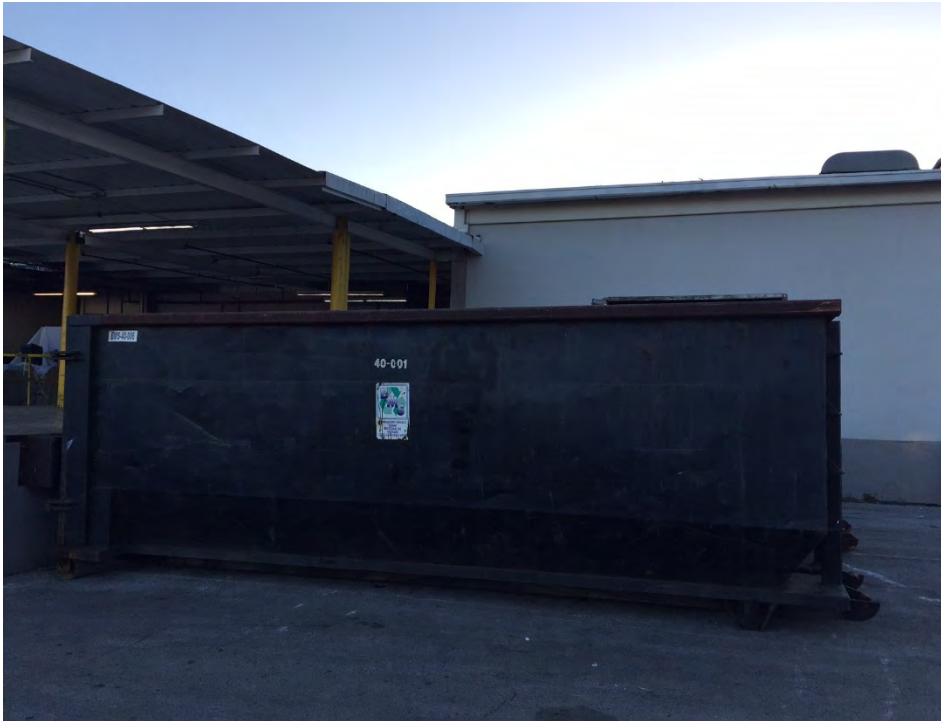
Photograph: 35

Description: View of Borinquen Metals storage container where removed metal pipelines were sent for recycling.
